L'Œuvre architecturale de Le Corbusier

[16] Musée National des Beaux-Arts de l'Occident

PLAN DE GESTION

**Preservation and Utilization Plan for
The Main Building of the National Museum of Western Art
(Important Cultural Property/Building)
And
The Garden of the National Museum of Western Art
(Registered Monument/Place of Scenic Beauty)**

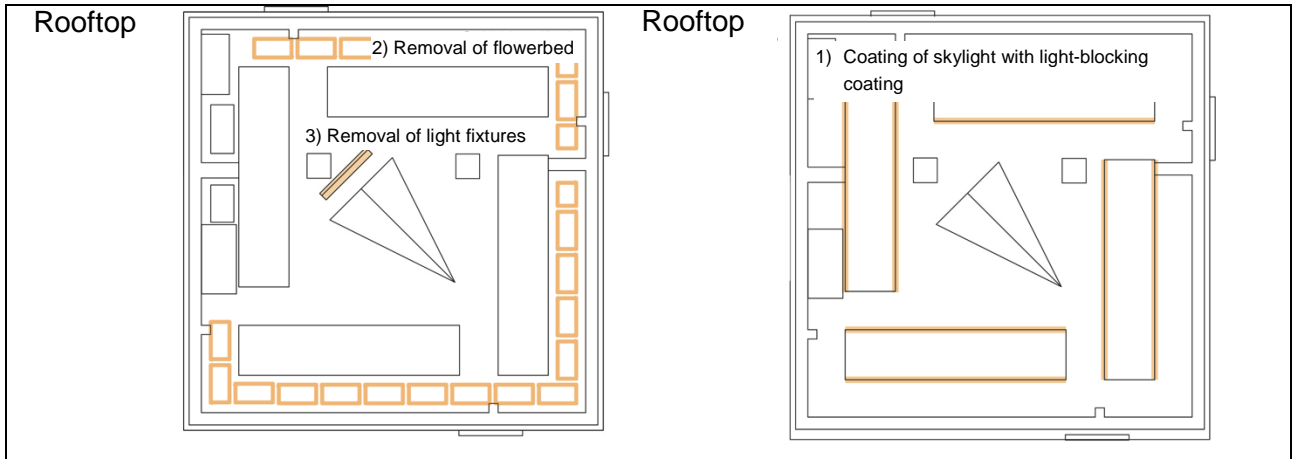
[Rooftop]

<ol style="list-style-type: none"> 1) To maintain temperature and humidity controlled conditions, the corrugated glass in the Skylights « <i>Lanterneaux d' éclairage naturel.</i> » was given a light-blocking coating. 2) The rooftop flowerbed was removed in 1965 when waterproofing work was carried out. 3) Rooftop equipment for indirectly lighting the 19th Century Hall was removed, along with its foundation work, in 1980. 	
When first built (1959)	Present (2013)

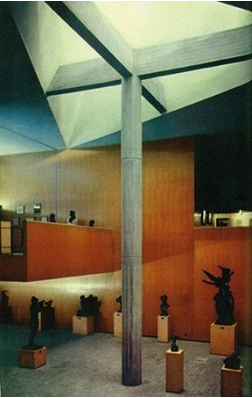
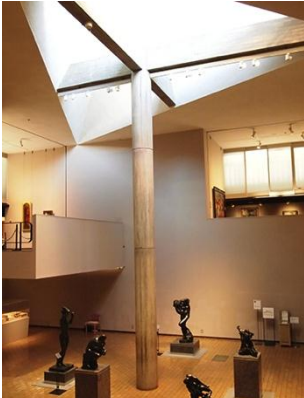
</div> <p>1) When first built</p> <div>

<p>1) Although the boundary between the 19th Century Hall and the third floor (now a storage space) is kept shuttered to preserve stable temperature and humidity conditions in the hall, space otherwise remains exactly as originally configured. The original lighting conditions featuring use of natural light have also been preserved, with natural light entering through a cross beam from the Skylight « <i>Lanterneau en forme de pyramide triangulaire.</i> ».</p> <p>2) In the exhibition rooms, the composition of the clerestory gallery and balcony projecting in a <i>swastika</i>-shape up to the third floor has been preserved in its original form, and original colors have also been largely preserved except on the inner peripheral wall on the hall side.</p>	<div>

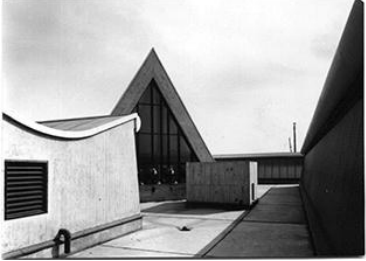
</div> <p>1) When first built</p> <div>

<p>The original shapes of rooftop structures and Skylights have been retained. The fittings and glass in the Skylight « <i>Lanterneau en forme de pyramide triangulaire.</i> » in the 19th Century Hall were twice replaced (in 1987 and 1995) to combat deterioration and provide better insulation. In 1995, emergency smoke release windows were installed to meet legal requirements, but care was taken to ensure the overall appearance was not significantly affected. The top and bottom housings of the corrugated glass in the Skylights « <i>Lanterneaux d'éclairage naturel.</i> » have also been improved, but the original shape (including the curved roof) has been preserved.</p>	
<div>

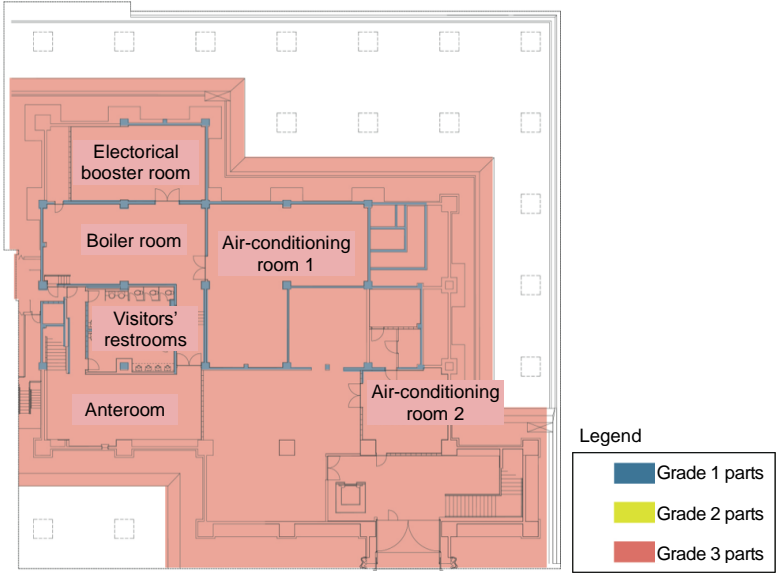
<p>First basement floor plan</p>

<p>Legend</p> <ul style="list-style-type: none"> Grade 1 parts Grade 2 parts Grade 3 parts
<p>* Interiors of all first basement floor rooms are excluded from the museum's designation as an Important Cultural Property. Machine rooms and similar facilities necessary to the building's functioning as an art museum need to be routinely replaced and managed, and so are classified as Grade 3.</p> <p>* Pillars, walls, and other structural parts of the building are classified like others as Grade 1.</p>
<p>First floor plan</p>

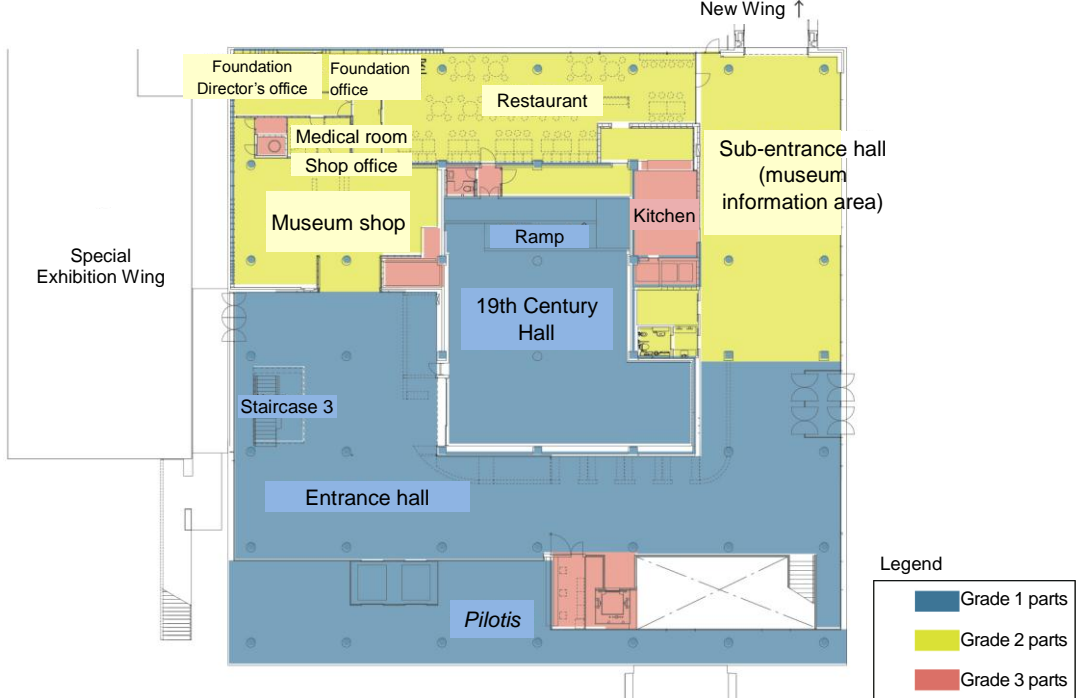
<p>Legend</p> <ul style="list-style-type: none"> Grade 1 parts Grade 2 parts Grade 3 parts
<p>* Pillars, beams, slabs, walls, and other structural parts necessary to maintaining the Main Building's spatial composition, along with the 19th Century Hall, <i>Pilotis</i>, and entrance hall existing since the museum was first built, are classified as Grade 1.</p> <p>* Interiors of service areas are classified as Grade 2.</p> <p>* Equipment space necessary to maintaining the building's functions as an art museum (such as duct space) is classified as Grade 3.</p>

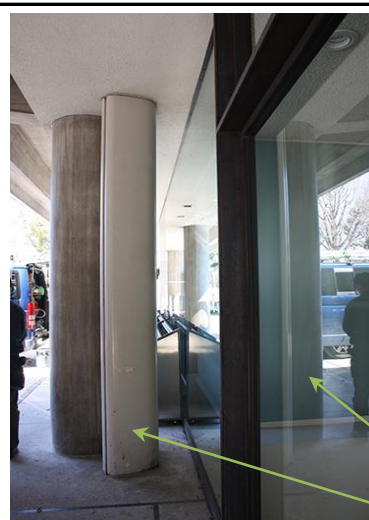
Pillars:
Category 1

Ceiling:
Category 2

Glass wall:
Category 4

Pipework:
Category 2

Number	Floor	Room name	<i>Pilotis</i>	Part grade
1	1			Grade 1
Element		Category	Present condition/description	Points to note (especially if continuity is required)
Floor		2	Mortar containing crushed stone with special seam finish	<i>Modulor</i> scale used for joint layout
Pillars		1	⊙Exposed concrete with natural imprint of the Japanese pine boards	Texture/gloss/color
Wall	Glass	4	Fixed-fitting float glass	Unobstructed view
Beam	Cantilever	1	⊙Exposed concrete with natural imprint of the Japanese pine boards	Texture/gloss/color
Ceiling	Ceiling	2	Lightweight steel-frame base, plasterboard with colored lightweight aggregate coating	Height: 2960/Color: white
	Periphery underside	1	⊙Exposed concrete with natural imprint of the Japanese pine boards	Texture/gloss/color
Fittings	Doors to and from Main Building	4	Automatic glass doors	Unobstructed view
Equipment	Ceiling lights	5		Shape, color rendering
	Pipework (guttering)	2	Steel cover	Shape

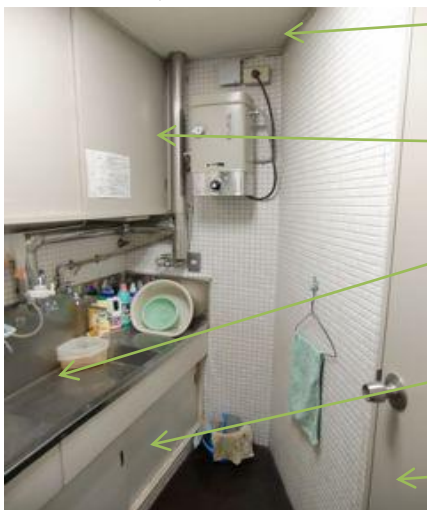
Ceiling: Category 2

Top storage shelves: Category 1

Number	Floor	Room name	Hot-water service room		Part grade
20	3				Grade 1
Element		Category	Present condition/description	Points to note (especially if continuity is required)	
Floor		3	Rubber tiles		
Wall	1 Inner side	1	©Lightweight concrete block base with octagonal glazed mosaic tiling (with partial exception)		
	2 Outer side	3	Concrete block base with plaster coating and emulsion-painted fabric finish	Color: red	
Ceiling		2	Lightweight steel-frame base, nonflammable plasterboard with colored lightweight aggregate coating		
Fittings		4			
Equipment	Ceiling lights	5			
	Top storage shelves	1	©		
	Bottom storage shelves	1	©		
	Sink	1	©Hammered stainless steel worktop	Hammered stainless steel	
	Range hood	1	©		
Notes	Double circle (©) in the "Present condition/description" column indicates elements date from original construction. Drainage pipes, gas appliances, etc. are Category 5

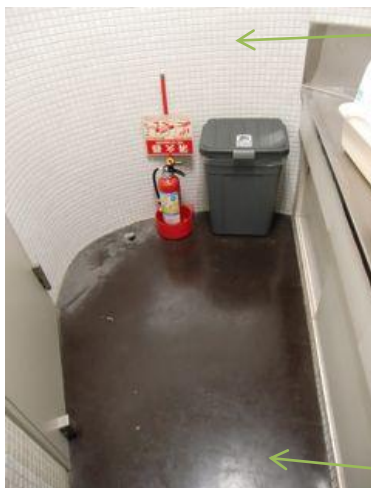
Bottom storage shelves: Category 1

Door: Category 4

Wall 1: Category 1

Floor: Category 3

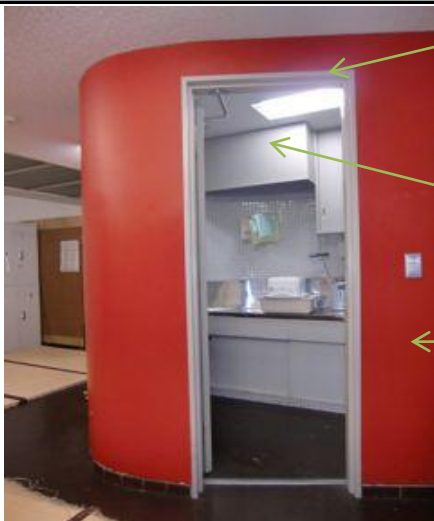
Ceiling lights: Category 4

Range hood: Category 1

Walls 2: Category 3

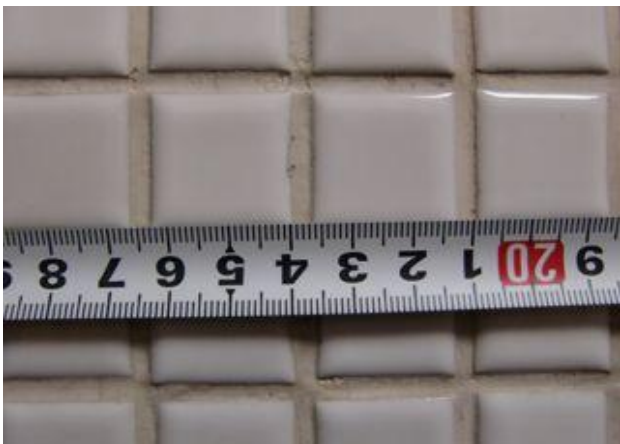
Walls 1: Category 1

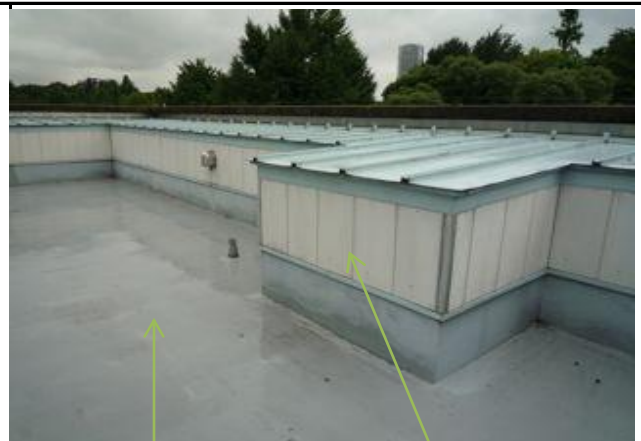
Roof floor: Category 4

Horizontal duct wall: Category 4

Number	Floor	Room name	Other rooftop area	Part grade
30	R			Grade 1
Element		Category	Present condition/description	Points to note (especially if continuity is required)
Floor	Roof floor	4	Urethane FRP composite waterproofing	
	Intake tower/exhaust tower	4	Waterproofing coating of urethane film	
	Smoke tower	4	Waterproofing coating of urethane film	
Wall	Intake tower/exhaust tower	4	Concrete base with sprayed tiles	
	Smoke tower	4	Concrete base with sprayed tiles	
	Horizontal ducts	4	Concrete base with sprayed tiles	
	Parapet coping	4		Facet dimensions
Roof	Horizontal ducts	4		
Ceiling	Smoke tower	1	(Ceiling section of former lift engine room)	
Fittings	Intake tower/ exhaust tower	1	◎1 south and 1 north of gallery, 1 inspection hatch (excluding hatch handle and cylinder lock)	
	Smoke tower	1	◎1 south of gallery, 1 inspection hatch (excluding mesh) (excluding handle and cylinder lock)

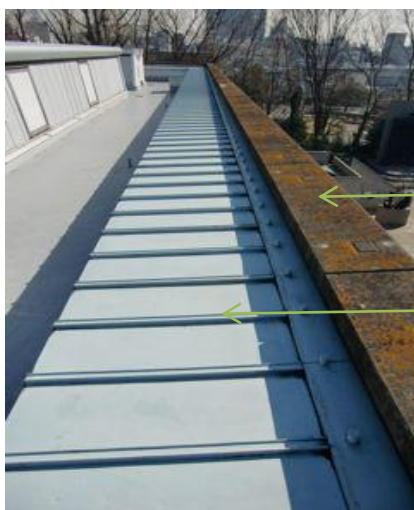
Parapet coping: Category 4

Horizontal duct roof: Category 4

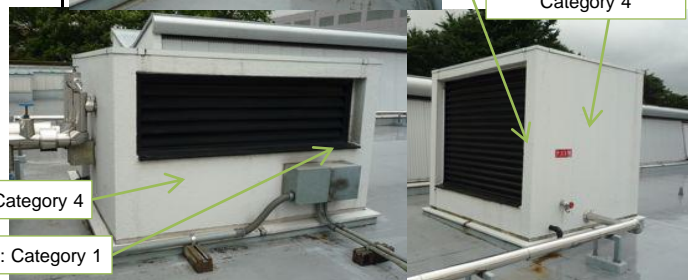
Exhaust tower fittings: Category 1

Exhaust tower wall: Category 4

Intake tower wall: Category 4

Intake tower fittings: Category 1

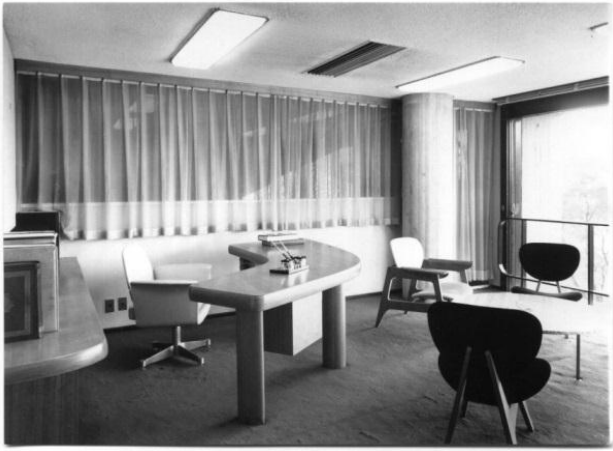
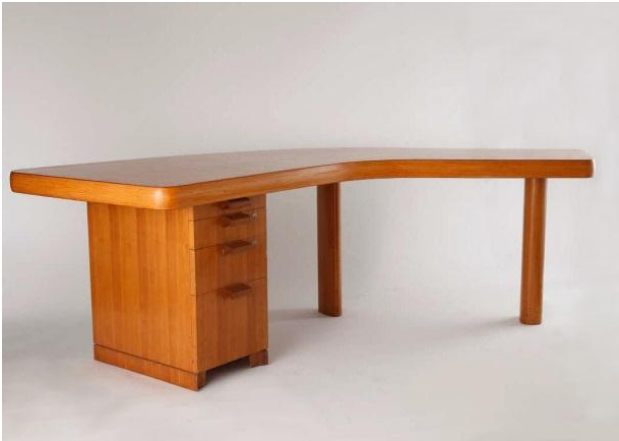
Director General's office when built	Director General's work desk (designed from sketches by Le Corbusier and now in the museum repository)

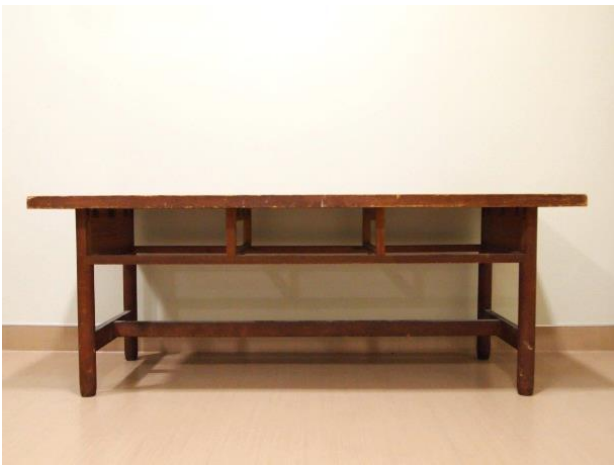
National Museum of Western Art plan 50098/furniture (5) “Detail drawings of work bench and tool rack” (November 30, 1957) National Museum of Western Art design office	Desk thought to have been used as a workbench (lacked drawers when identified) (2 in total: 1 in research materials center and 1 in display preparation room)
